Mexican Hat, Utah, Disposal Site

12.0 Mexican Hat, Utah, Disposal Site

12.1 Compliance Summary

SUBJECT: MEXICAN HAT DISPOSAL SITE
OBSERVATIONAL SITE VISIT

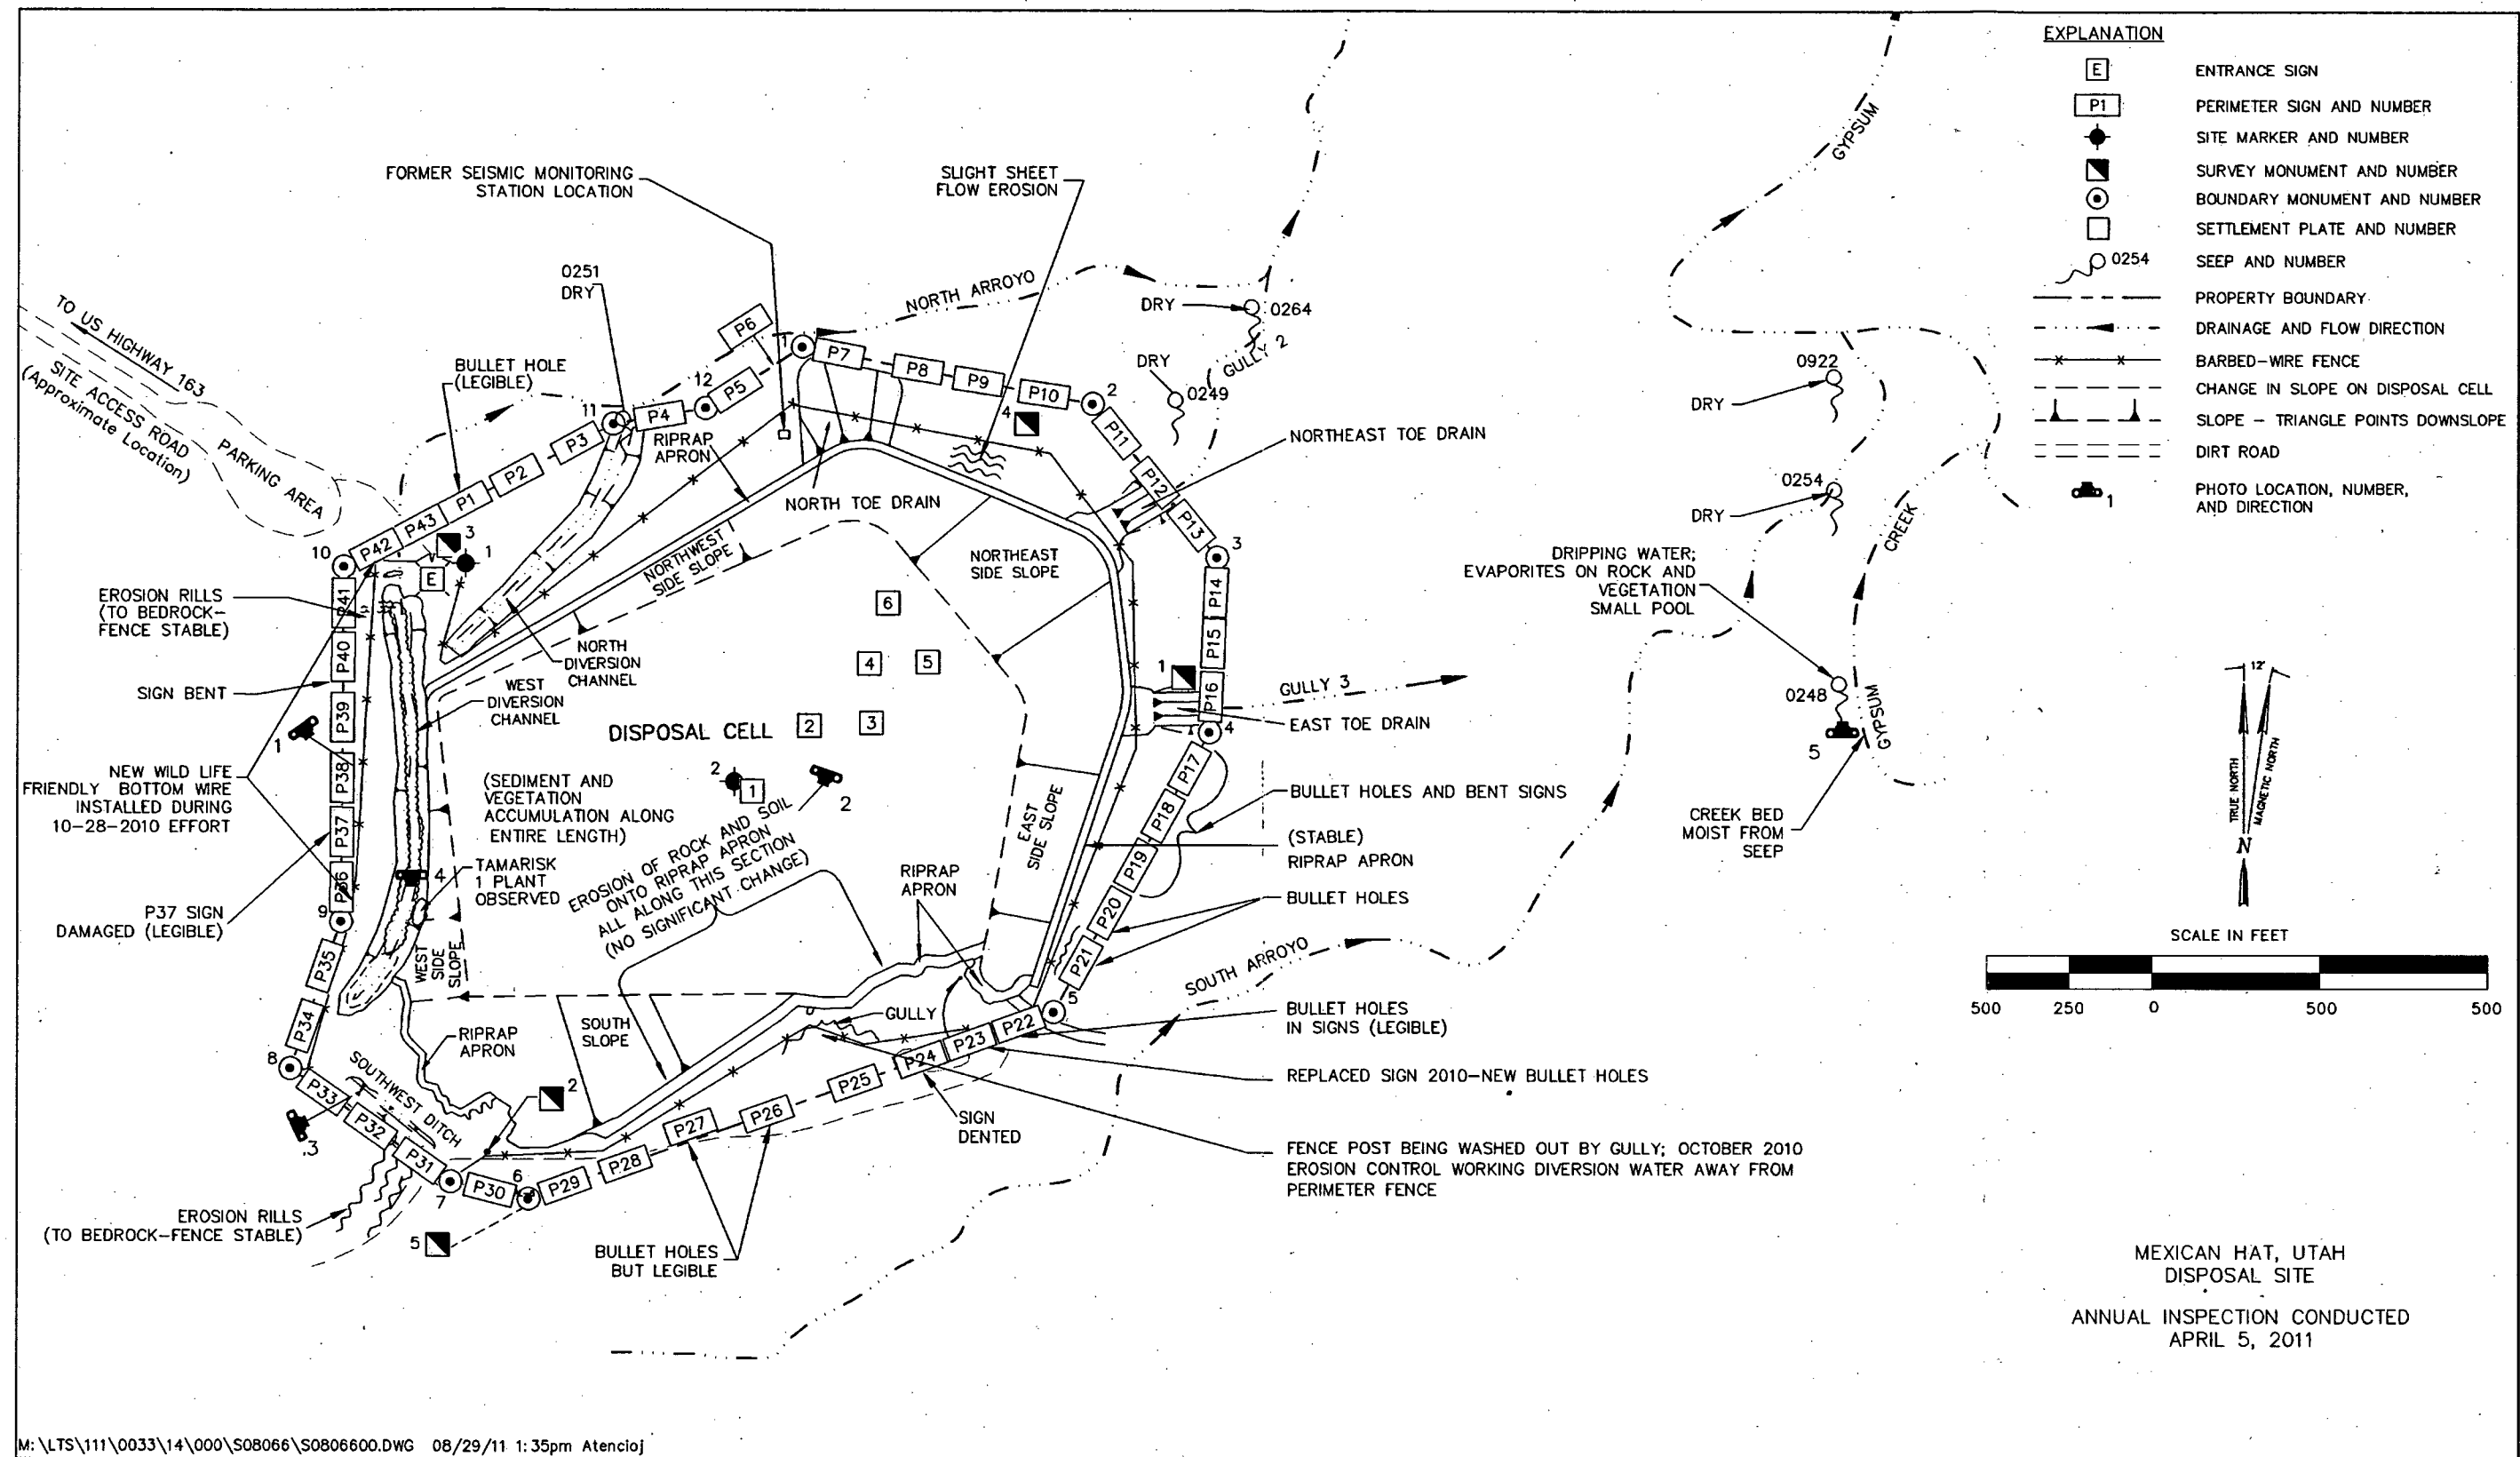
Figure 12-1. 2011 Annual Compliance Drawing for the Mexican Hat Disposal Site

A barbed-wire perimeter fence is located between the disposal cell features and the site boundary. Other than erosion of soil down to rock at a couple of locations near the south and southwest diversion channel, the perimeter fence is in excellent condition. Periodically, the fence is damaged by livestock or erosion and requires repair. Erosion has increased the spacing between the lowest strand and the ground surface between perimeter signs P37 and P40. An additional strand of non-barbed (wildlife-friendly) wire was added in 2010 (PL–1). Erosion continues to migrate up to the end of the west diversion channel at perimeter signs P42 and P43 but is not a concern at this time.

The entrance sign located at the gate is in excellent condition. There are 43 perimeter sign locations, and each location has a pair of signs: an upper property ownership sign and a lower radioactive materials disposal site warning sign. The perimeter signs were present and legible although several are bent or damaged by bullet holes. Several signs on the south boundary, including the replaced perimeter sign P23, which was moved inside the perimeter fence, have new bullet holes after being replaced in October 2010.

Site Markers and Monuments—The 2 site markers, 4 survey monuments, and 12 boundary monuments were inspected. All were in good condition. Boundary monument BM–11 is in an area subject to erosion but remains stable.
